# REPAIRING WORKS IN RIVETED STEEL TANK WITH 5000 m<sup>3</sup> CAPACITY

Lyubomir A. Zdravkov<sup>1</sup>

*Science conference UACG' 2008*

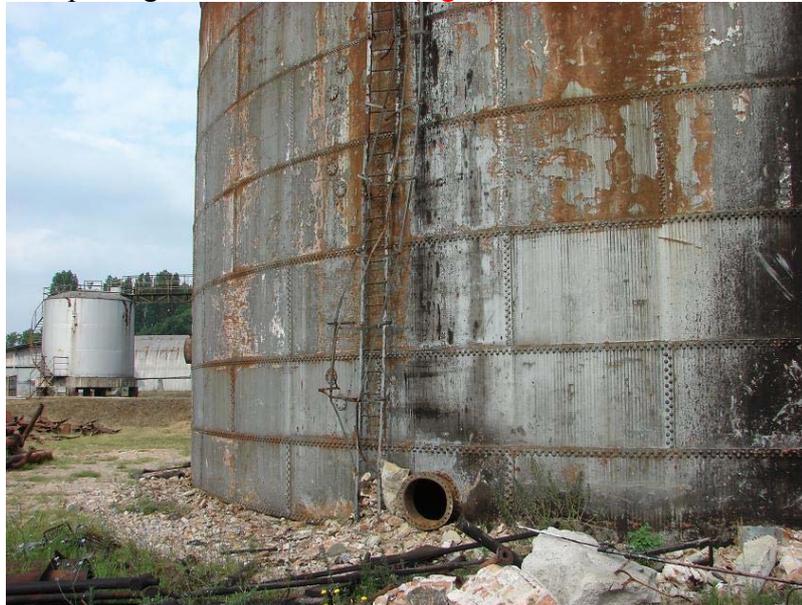
The device has been successfully used for long years but a leak appeared and for this reason it has been emptied and put out of exploitation. After that the tank remained empty without any maintenance. Its condition before the repairing works can be seen (fig. 1).

fig. 1 Tank's condition before the repairing works

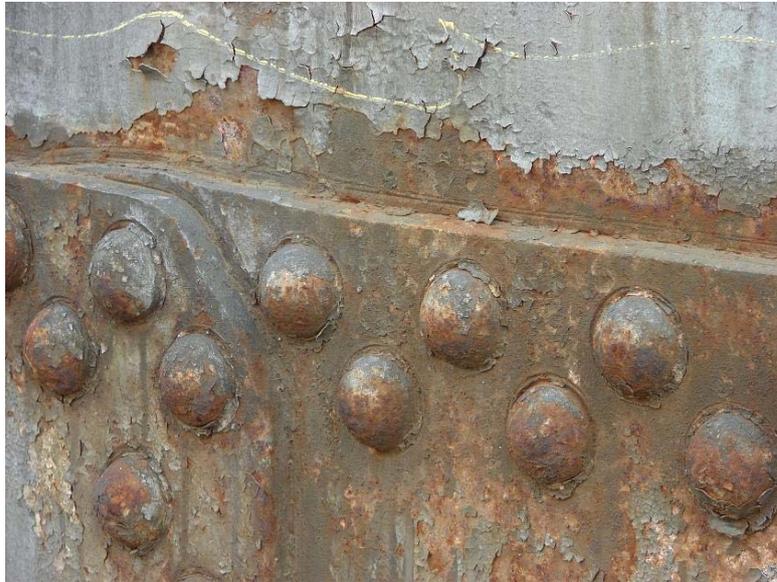
Project data for this tank are missing – stored product, maximum liquid level, over pressure and negative pressure in the tank, used steel, thickness of the constructive elements. Unknown is also the year of the beginning of exploitation. Proceeding only from the fact that the bottom, the shell and the roof are connected with rivets (fig. 2), we can presume that this tank has at least 60 years.

fig. 2 Connection of the sheets with rivets

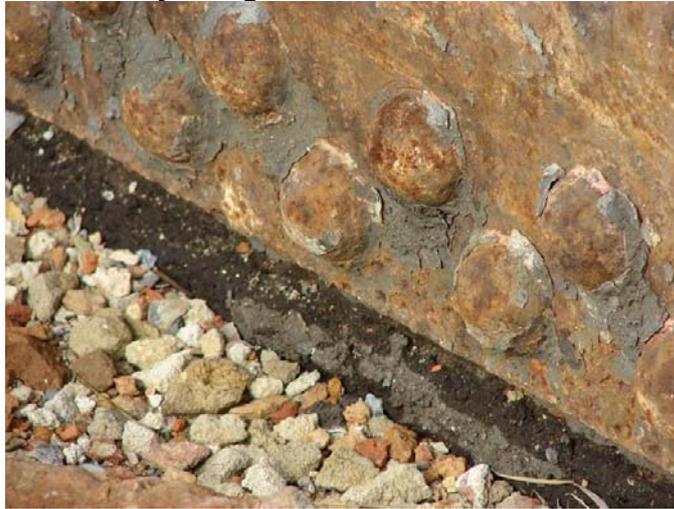
fig. 3 Joint of shell and bottom plates of the tank

Because the jointing angle section in the lower supporting joint is extremely corroded we can not rely on its bearing capacity. It shall be removed or appropriately strengthened. Scheme for initial joint shell-bottom as well as examined versions for replacing of the bottom is shown on fig. 4:

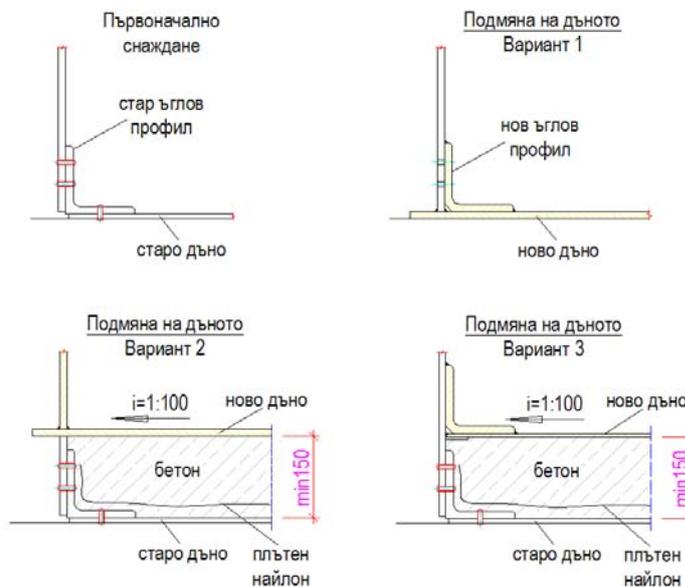
fig. 4 Versions for new joint bottom –shell

Bottom replacement has been done according to the Version 3 which specialties for execution are:

- thickness of sheets in the new bottom is  $t_b = 6$  mm and it is determined according to [2];
- steel for the annular bottom plates is S355, and for the central part – S235;
- bottom sheets are welded to the shell with butt weld with full penetration. Under new bottom plates are used steel plates to ensure welding of root of the butt weld;
- new joint between the bottom and shell is reinforced through additional angular section L120x10, which shall decrease the tensions caused by the bending in the joint shell –bottom. The end of the section is beveled in order that the butt joint shell – bottom will be done with smooth transition to the shell.
